Follow-up Site Inspection Summary

PATH #: 21-HPAC-01541

FILE NAME: Ship-breaking and Vessel Grounding, Union Bay, Union Bay

DATE: 7 June 2023

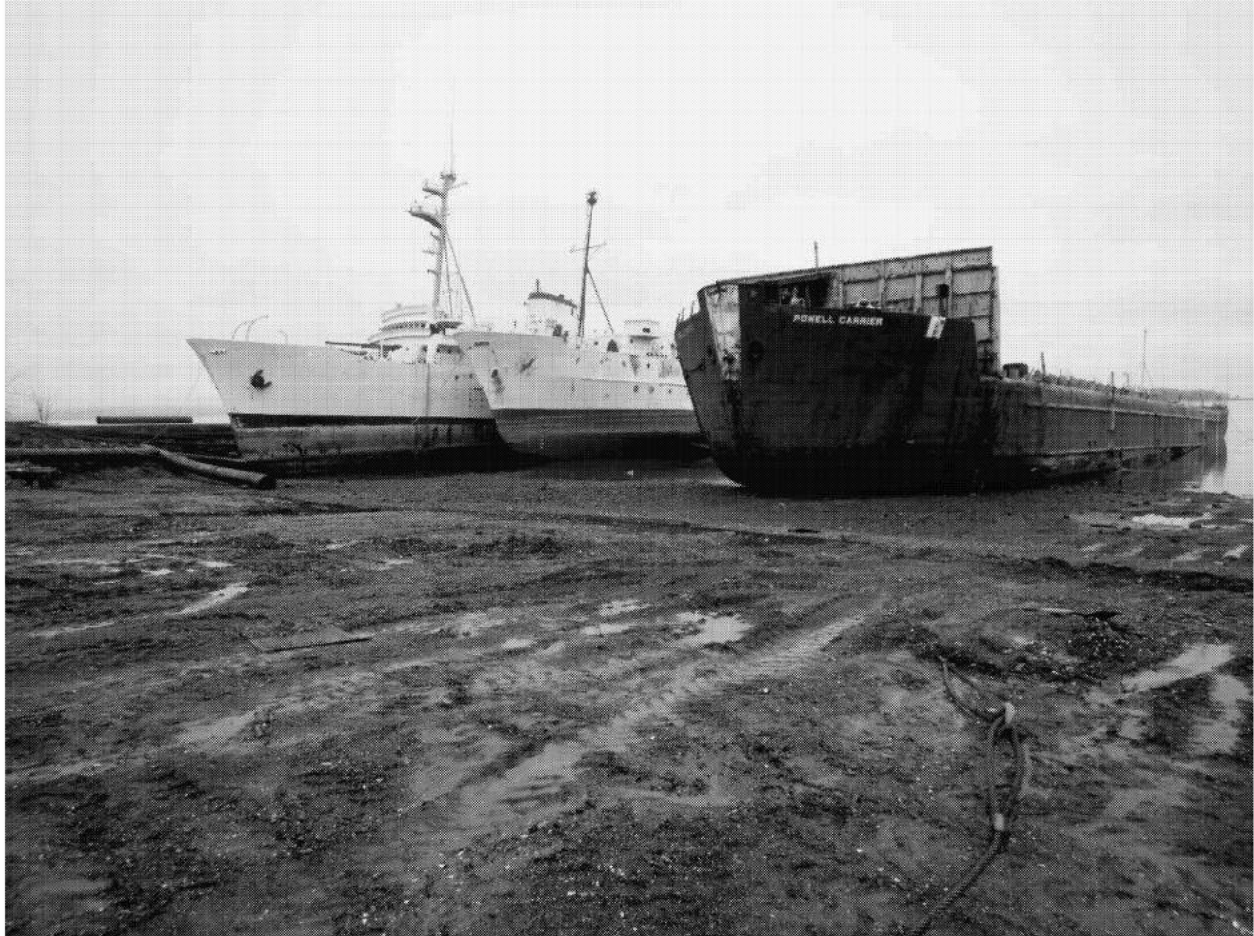
Photo 1. The barge and three vessels that were grounded in the intertidal zone on 3 February 2022.

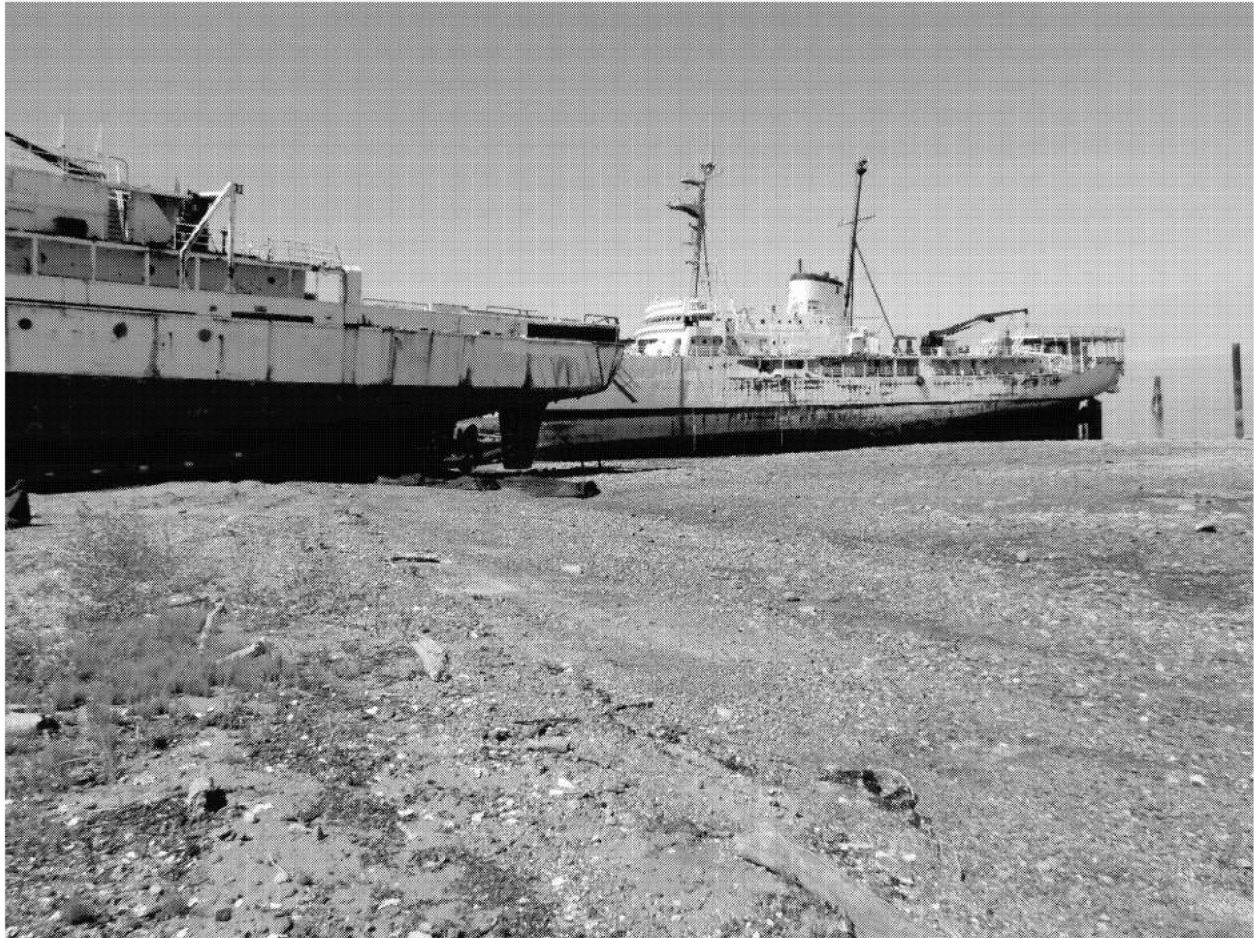
Removal of the barge and one of the moored vessels has addressed >70% of the HADD associated with WUA #3 in the Annex 4. The continued presence of the third moored vessel in the intertidal zone does not result in any additional HADD but the site cannot recover until the vessel is removed from the water. Both of the moored vessels were located within the log watering area (log pocket) when the site was used as a log sort. This area was regularly dredged during log watering operations but has since infilled with sand and layers of wood debris. The area is in the process of recovering from past industrial use for log handling and wood waste was still present in the intertidal zone on the site. Recolonization of the sand substrate in the log pocket and where the vessel had been moored was evident from the presence of ghost shrimp, bivalves, and polychaetes.

Photo 2. The remaining vessel moored in the intertidal zone (background) and the mostly removed vessel in the foreground. The grounded barge observed on 3 February 2023 was no longer present.

- 1) The final vessel should also be removed from the site to allow for continued recovery of the site. It is understood that there have been challenges and associated delays with removal of the first moored vessel. While the preference is to have the final vessel removed as soon as possible, the continued presence of the vessel will not result in a further HADD or death of fish but only delay recovery of the remaining portion of the site. Removal of the barge and first vessel has allowed for recovery to begin on >70 % of the area originally impacted and minor delays in the schedule to ensure that the final vessel can be safely and efficiently removed will not further impact fish habitat.

- 2) Prior to removal, vessels should only be moored below chart datum and in sufficient depths to avoid grounding at low tide. Vessels should only transit the intertidal zone during a high tide when they are being removed from the marine environment.
