Report Number: 241941

### **Re: Administrative Penalty Referral**

On March 28, 2025, Ministry of Environment and Parks (Ministry) Officers Jurgen Deagle (Officer Deagle) and Bryan Vroom (Officer Vroom) conducted an on-site inspection of the Deep Water Recovery Ltd. (DWR) facility located at 5084 Island Highway South, Union Bay, B.C. (Facility), followed by an office review inspection on April 16, 2025. The inspection was conducted to verify compliance with Pollution Abatement Order 112057 (Order) which requires DWR to:

### **This Inspection is being referred for an Administrative Penalty for failing to comply with Order Required Actions 1 and 4.**

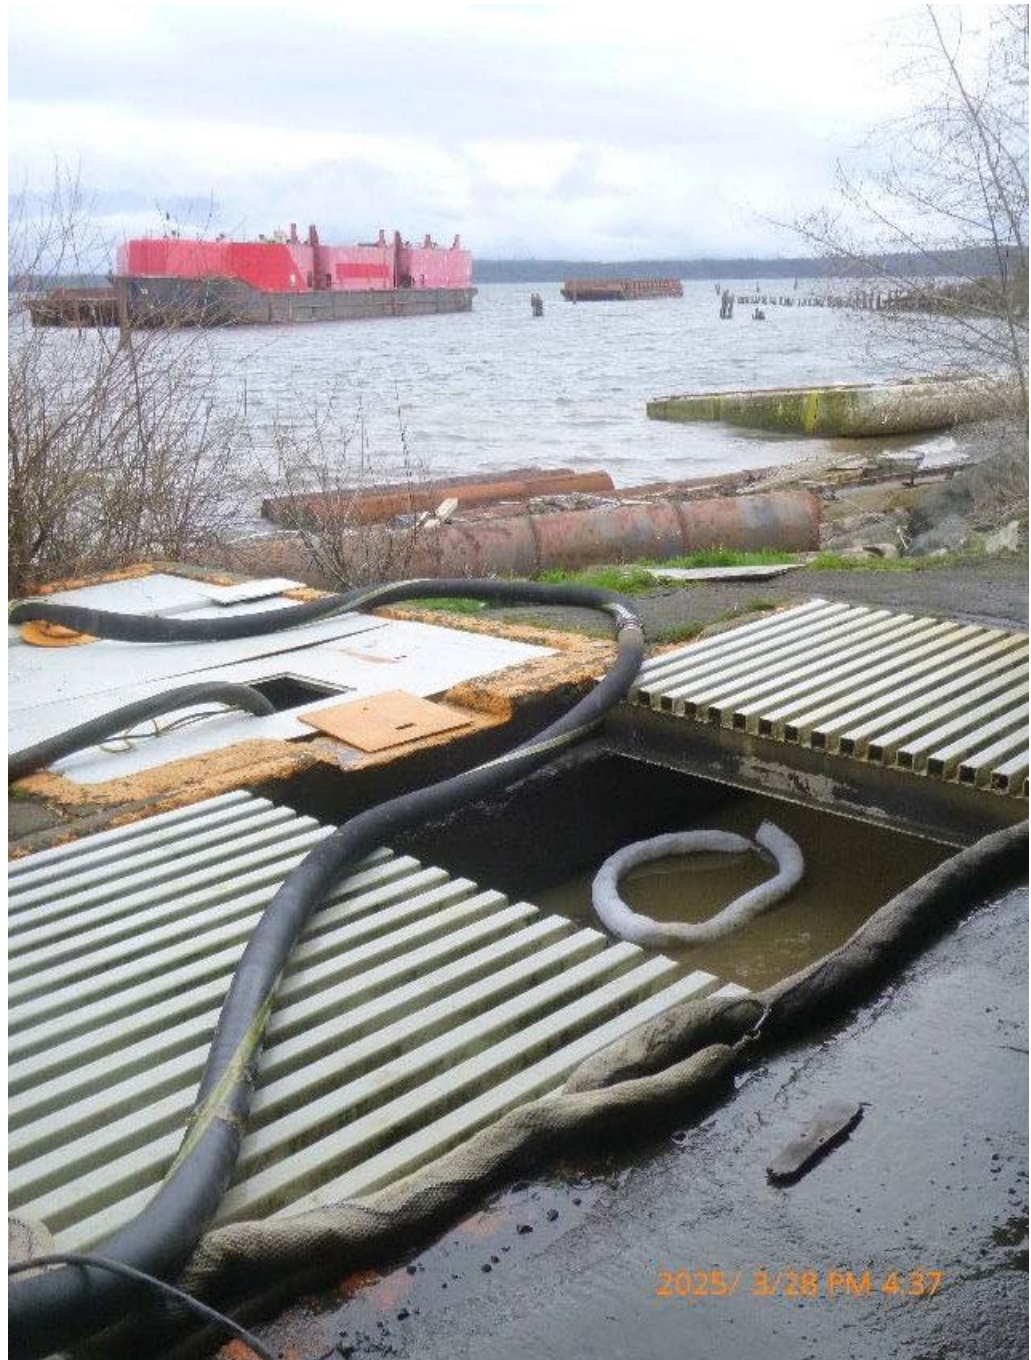
- Sump 1 is a concrete, oil-water separator located in the center of the east edge of the Facility and collects water from the paved central area (See Appendix 2: Photo 1). There was no reported discharge from Sump 1 in January, February or March 2025, and it was not discharging during the March 28, 2025 site inspection. The March 2025 Monitoring Report explained the lack of discharge by noting that water from Sump 1 was treated in the water treatment system and the holding tank did not reach capacity to require discharge during the month.

Sump 1

March 28,  
2025

The 2024 Treatment Plan includes multiple actions to bring DWR into compliance with the Order. One of the key actions is installation of a new water treatment system at Sump 1 to reduce total and dissolved copper, lead, and zinc

concentrations in storm water discharged from all areas of the Facility. According to the November 2024 Monitoring Report Correction, Sump 1 receives the majority of water from the paved area of the Facility (See maps in Appendices 1 and 3). In the 2024 Treatment Plan, DWR states, "The catchment area for Sump 1 is the area where vessel repair, maintenance, and recycling will take place." The February 2025 Monitoring Report states that the water treatment system was installed by February 15, 2025, and was in the commissioning phase. The March 2025 Monitoring Report states the water treatment system is in place at Sump 1 and is in the commissioning phase.

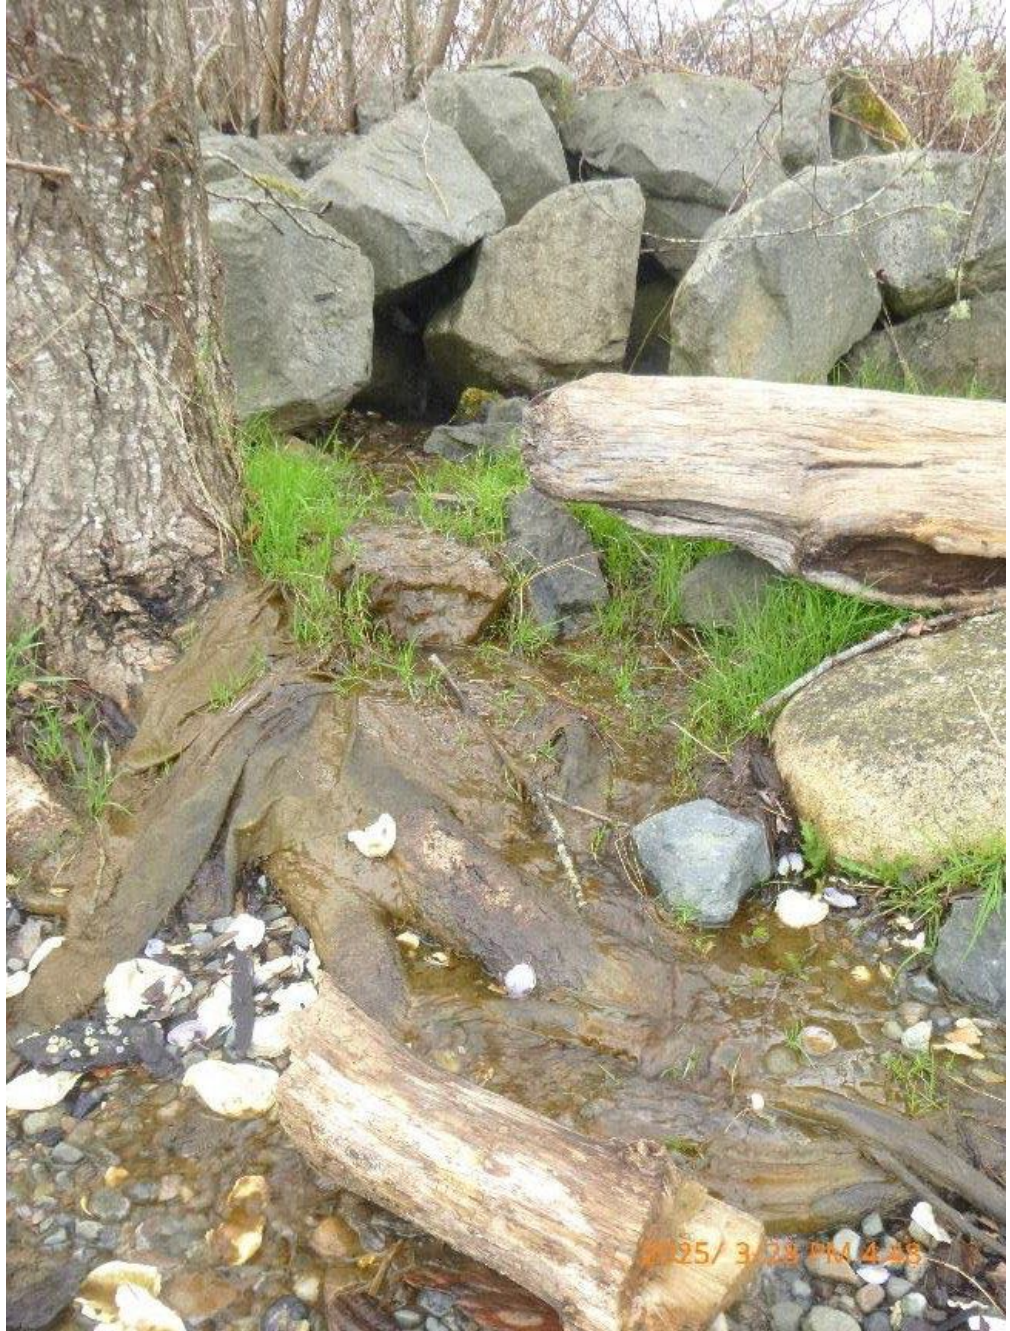
Photo 2  
Sump 2  
Discharge  
March 28,  
2025

- Sump 2 is a collection pond, with a discharge pipe onto the foreshore, located at the southeast corner of the Facility. According to Figure 5-5 in the 2024 Treatment Plan, collects run-off water from the gravel pad area. Aerial images of this area show vessels in this area on March 11 and 28, 2025 (See Appendix 2: Photos 2, 3, 4, 5). Sump 2 was discharging during the March 28, 2025, site inspection.

- The discharge sample collected from Sump 2 on March 28, 2025, exceeded the BC WQG Short Term (Acute) limit for copper by 330%.
- The discharge sample collected from Sump 3 on March 28, 2025, exceeded the BC WQG Short Term (Acute) limit for copper by 327%.
- The discharge sample collected from the Foreshore area on March 28, 2025, exceeded the BC WQG Short Term (Acute) limit for copper by 4933% and exceeded BC WQG Short Term (Acute) limit for zinc by 229%  
(See Result Summary in Table 1 and laboratory certificates of analysis in Appendix 4).

- Immediately cease the release or discharge of effluent with concentrations of copper, lead and zinc above BC WQG levels.

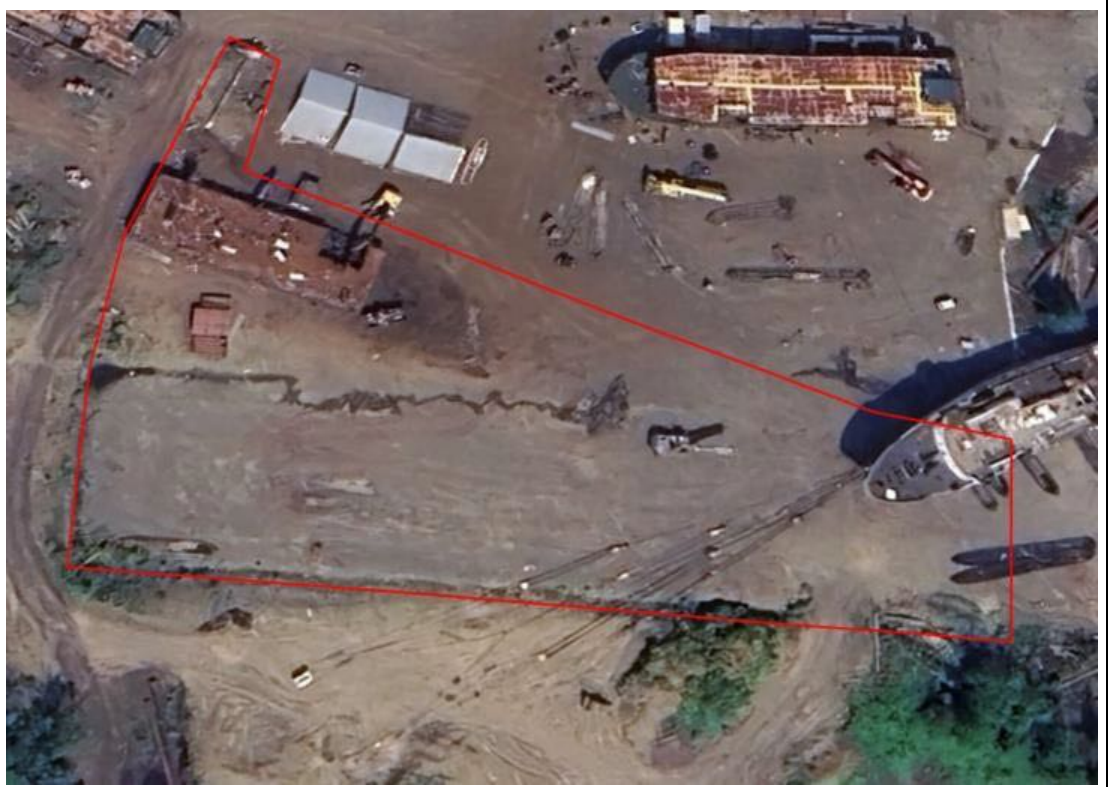
Photo 3

Sump 2  
Catchment  
Area

Figure 5-5  
from DWR  
2024  
Treatment  
Plan October  
31, 2024

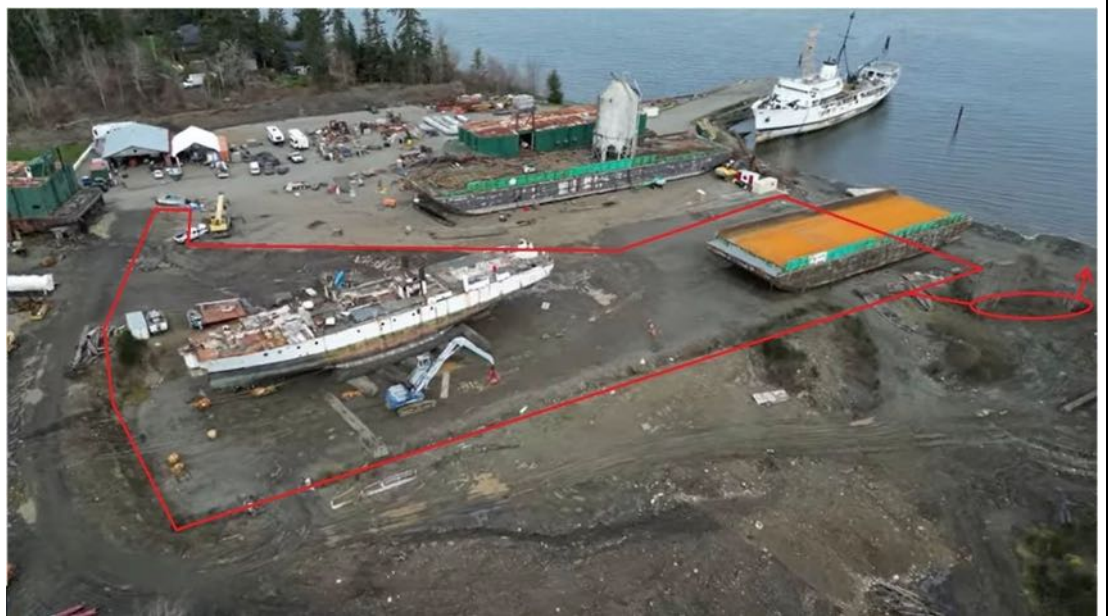
Photo 4

Sump 2  
Catchment  
Area (approx.)

March 11,  
2025

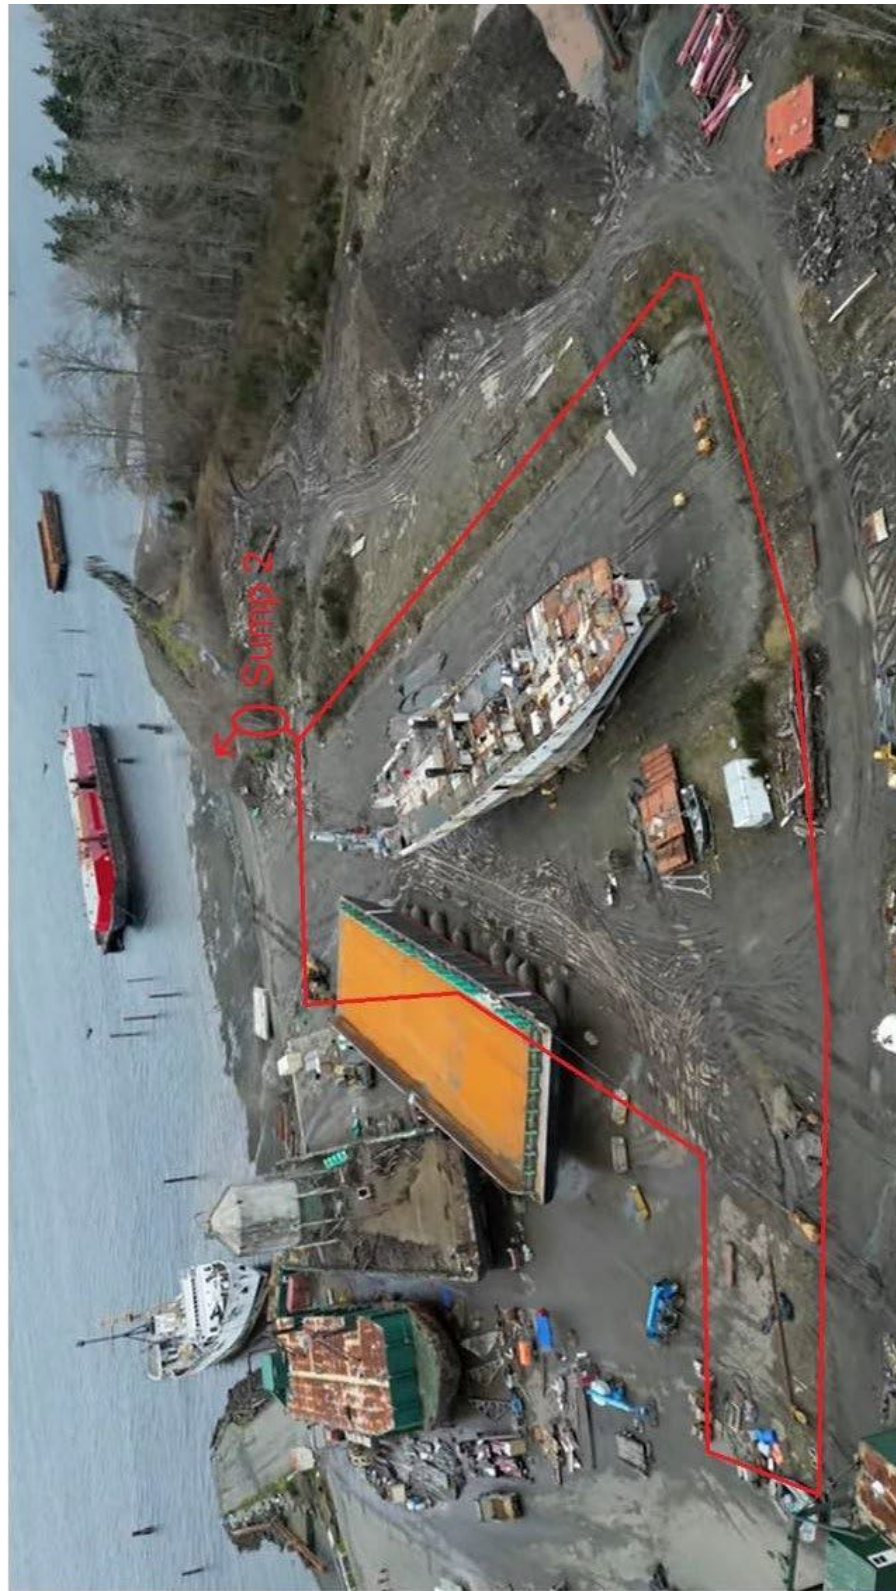
Photo 5

March 28, 2025

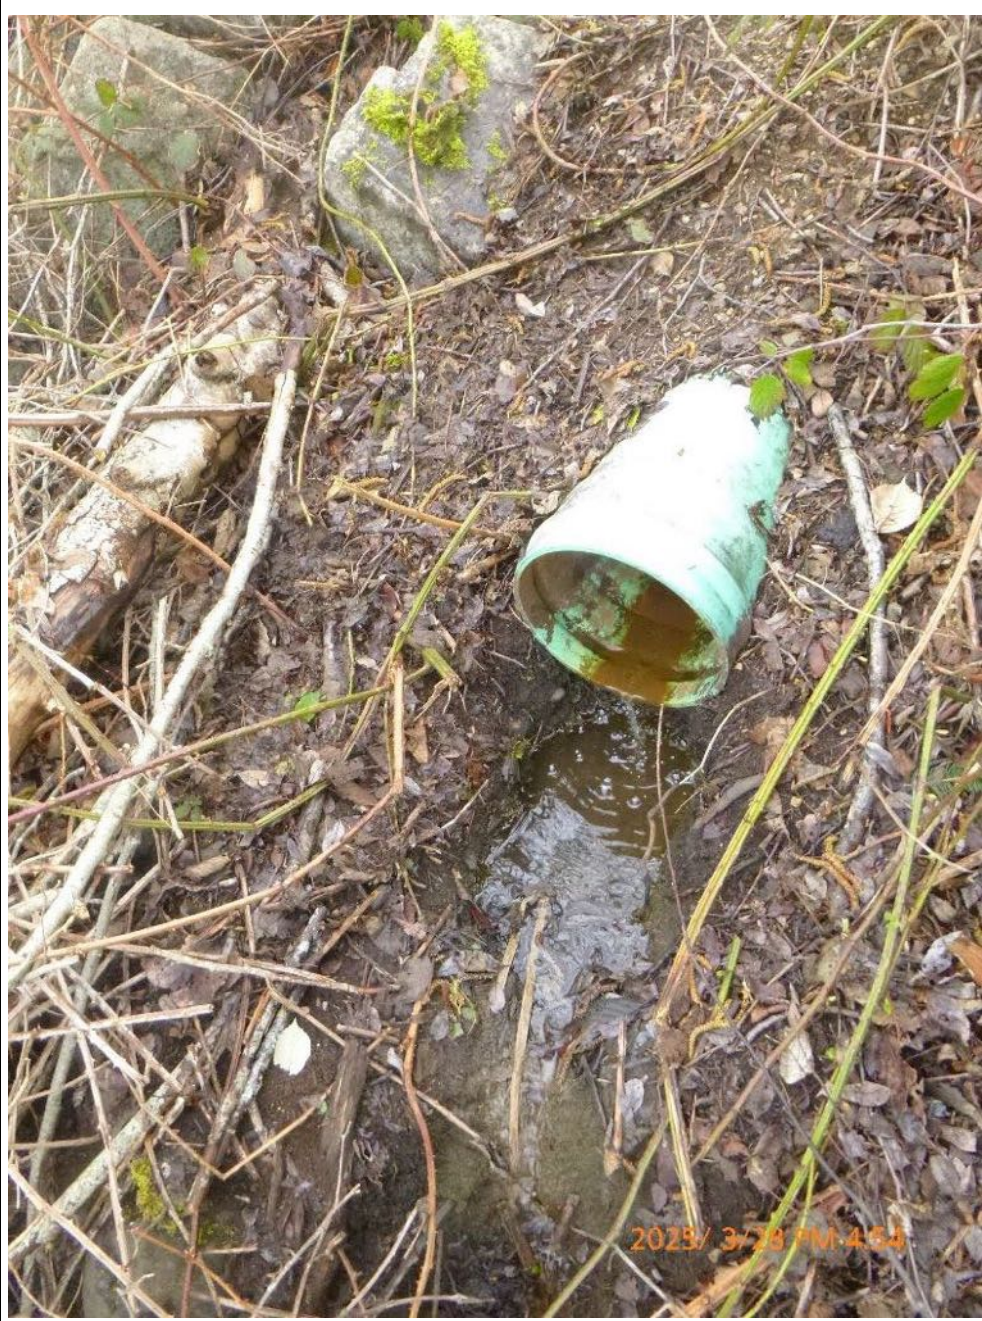
Photo 6

- Sump 3 is a collection pond, with a discharge pipe to the ground 2 meters from the foreshore, located at the northeast corner of the Facility. It collects surface water from the northern part of the paved area of the site (See Appendix 2: Photo 6). Sump 3 was discharging during the March 28, 2025, site inspection.

Sump 3  
Discharge

March 28, 2025

During the March 28, 2025 on-site inspection, Officers observed that Facility modifications listed in the 2024 Treatment Plan had not been completed. There was no 6 meter asphalt berm along the south side of the asphalt pad; the three French drains had not been installed in the gravel pad; no oil-water interceptor was installed; the gravel pad had not been re-graded to slope north-south; Sump 2 was not decommissioned; the wood waste berm was not fully removed; the stockpiled wood waste berm material south of the gravel pad was not tarped to prevent the generation of leachate; no asphalt berm was installed along the northern edge of the asphalt pad and Sump 3 was not decommissioned.

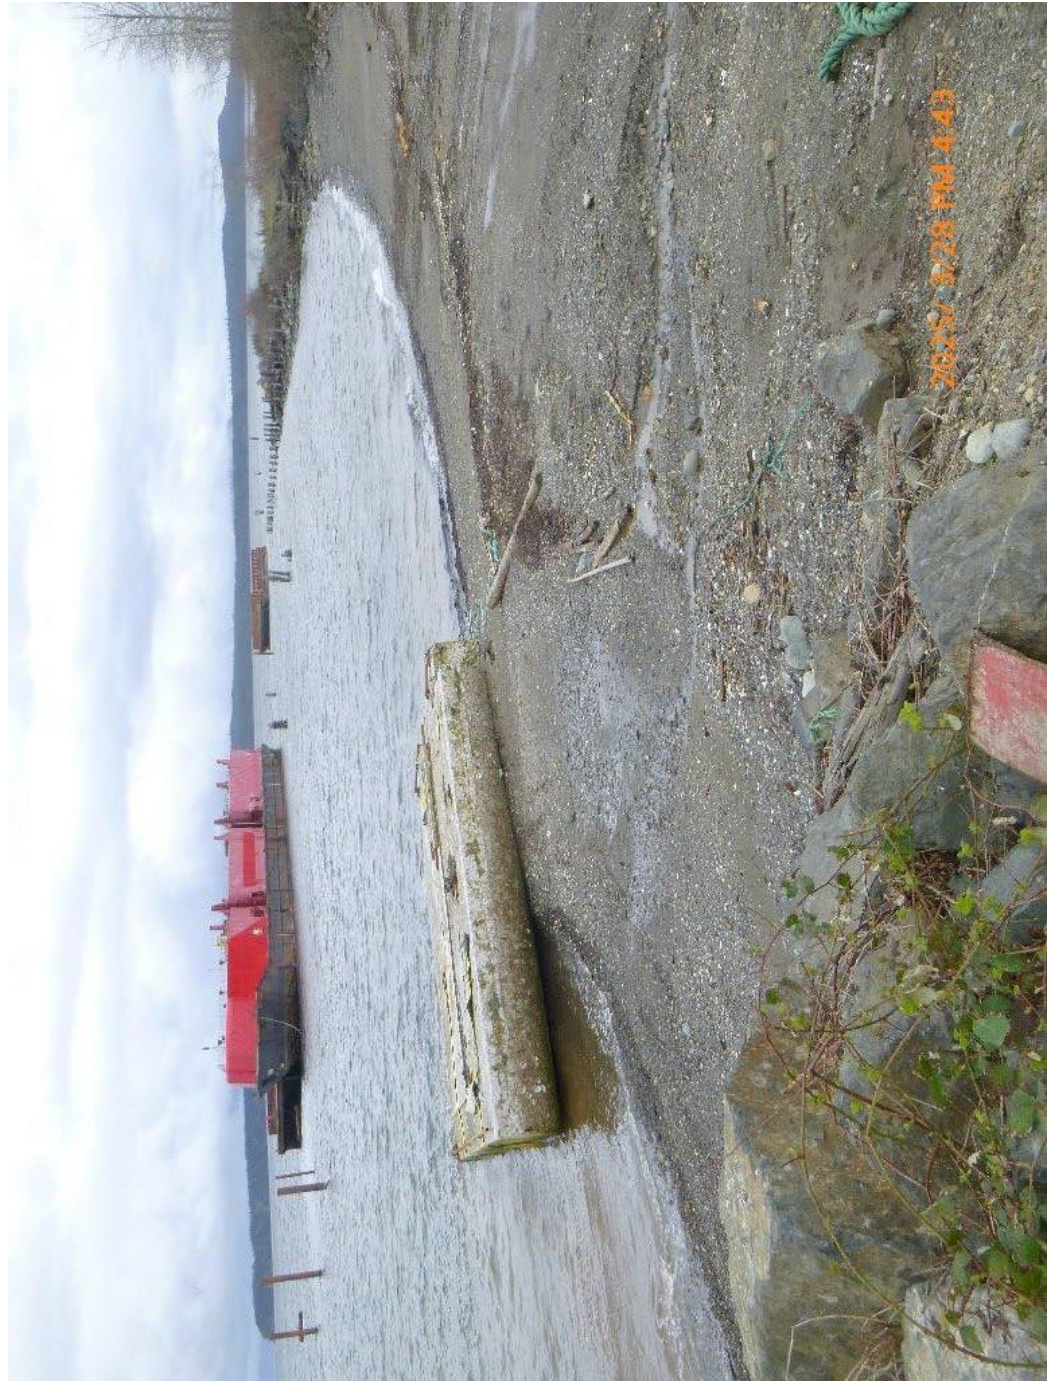
Photo 7

- The Foreshore is a gravel beach area between the high and low water mark of Baynes Sound along the eastern boundary of the Facility (See Appendix 2: Photos 7, 8). Discharges from the Foreshore are visible in March 14, 15, 17, 20, 21, 22, 24, 25, 26 and 27 Drone Videos (e.g. See Appendix 2: Photos 9, 10, 11, 12). There was discharge to the Foreshore during the March 28, 2025, site inspection.

Foreshore  
Area w.  
discharge  
channel

March 28,  
2025

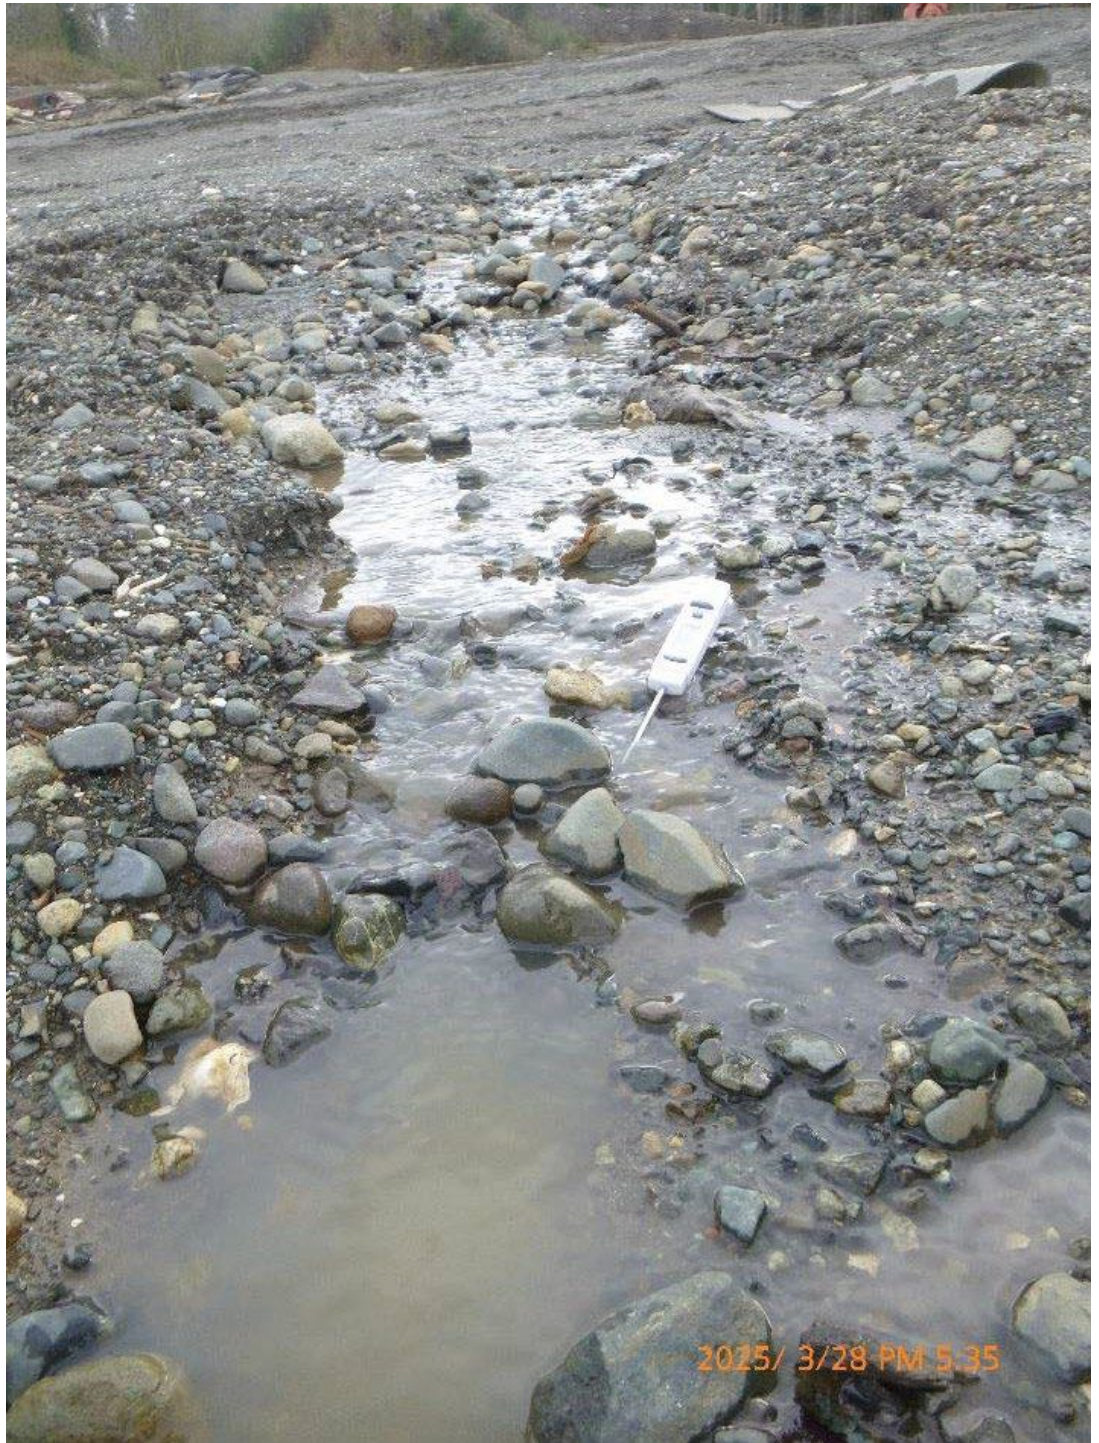
Photo 8

Foreshore  
Area  
Discharge

March 28,  
2025

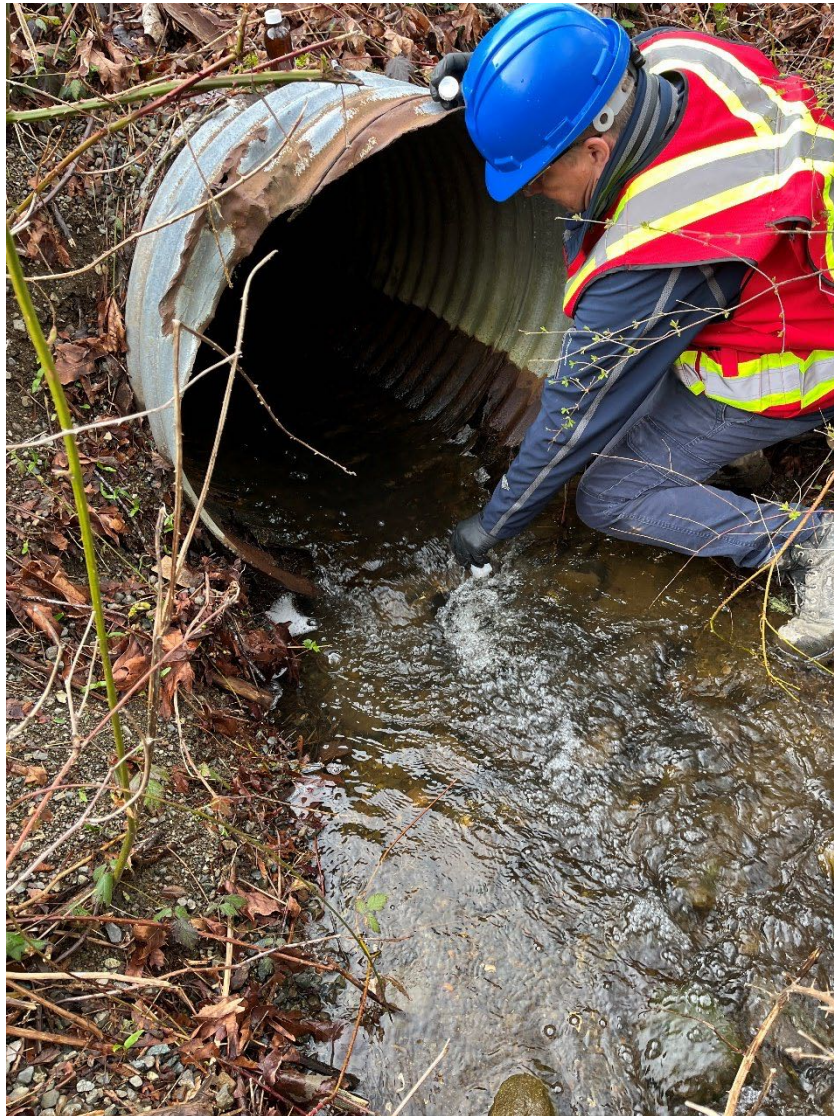
Photo 13

- North Creek / Hwy culvert is located upslope of the Facility and is a defined creek channel, with flow most of the year. The creek is directed across the Facility entrance and flows along the Facility Boundary to Baynes Sound (See Appendix 2: Photo 13). North Creek is a reference sampling point for surface water discharges upslope of the Facility. It does not flow onto the Facility and is not the origin of water that discharges from the Facility.

North Creek /  
Highway Culvert  
Sample Point

March 28, 2025
