Remediation of a Coal Waste Pile in Union Bay, BC

Tara Siemens, MET and Ian Mitchell, MSc, PGeo
SEACOR Environmental Inc.

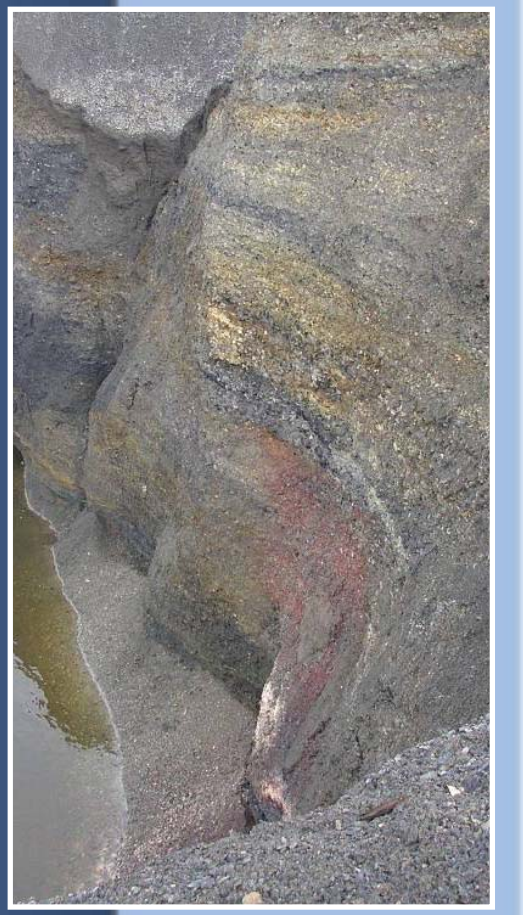
Geochemistry

- Geochemical characterization conducted by SRK Consulting (Canada) Inc.
- Static and kinetic testing conducted
- Testing indicated that all material is potentially acid generating or is already acidic
- Geochemical Profile
  - Sulphide sulphur present throughout
  - Accumulation of sulphate within top 2 m
  - Increasing pH and NP with depth
- Under existing conditions, acidification expected to continue for decades to a century

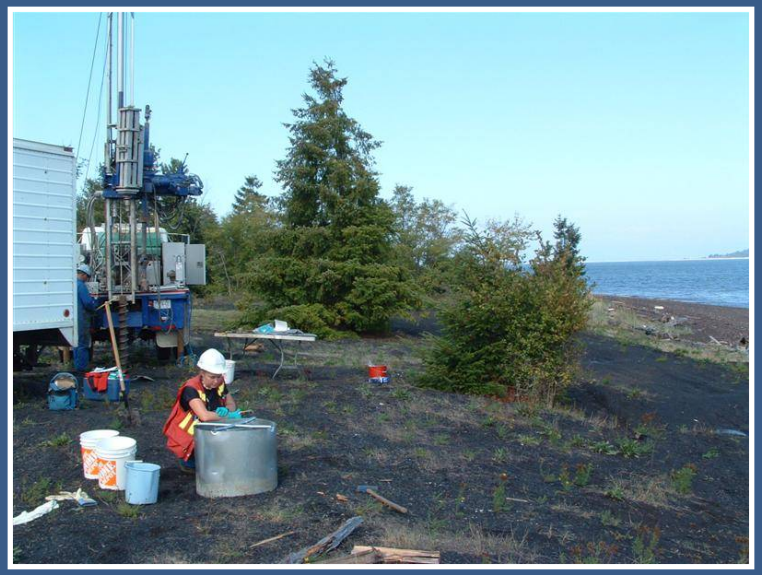
Infiltration Test Results

- Infiltration rate at 20cm depth is 5x greater than infiltration rate at typical surface locations
- Infiltration rate at typical surface locations is 10x greater than highly compacted surface areas

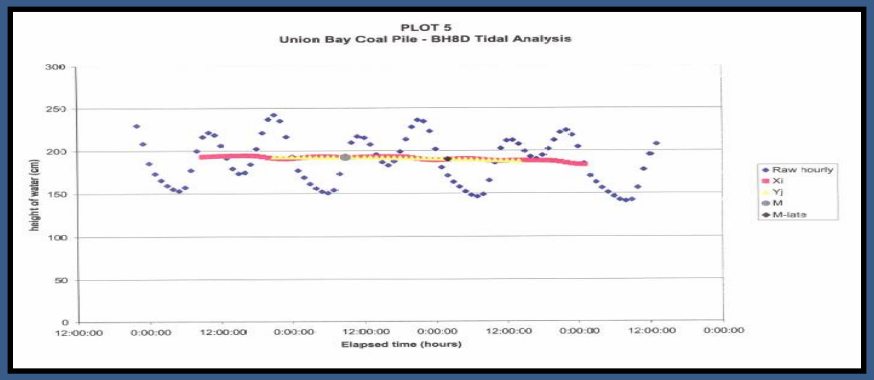
Tidal Analysis

- Tidally induced groundwater fluctuations 1.5m adjacent to foreshore; absent 400 metres inland
- Intrusion of saline groundwater observed to 75m inland
- Upgradient third of pile not exposed to tidal flushing

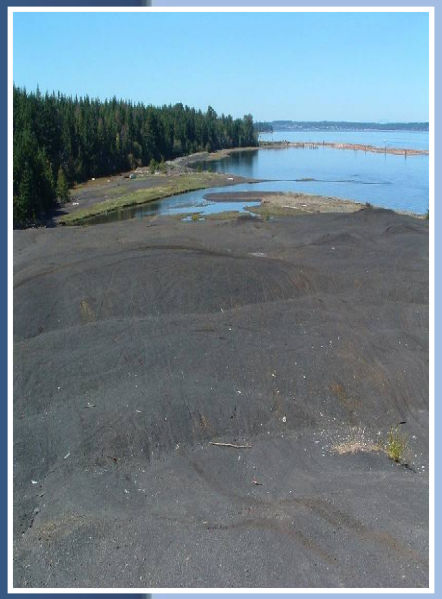
Cover Design Considerations

- Climatic water balance for the pile is net positive
- Main risk to low permeability cover is dessication due to wet/dry cycles
- Regrading of steep slopes required
- Special design considerations for contact areas with roadways, foundations
